## THE EFFECTS OF THE WRONG LUBRICATION METHOD OF THE GEAR TRAIN

*In the article it is presented the remanufactured gearbox of the ball mill drive in the cement works. The first stage of the gearbox gear trains is wrong lubricated in operation. And the consequences of this error in lubricating are shown and analyzed in the article.*

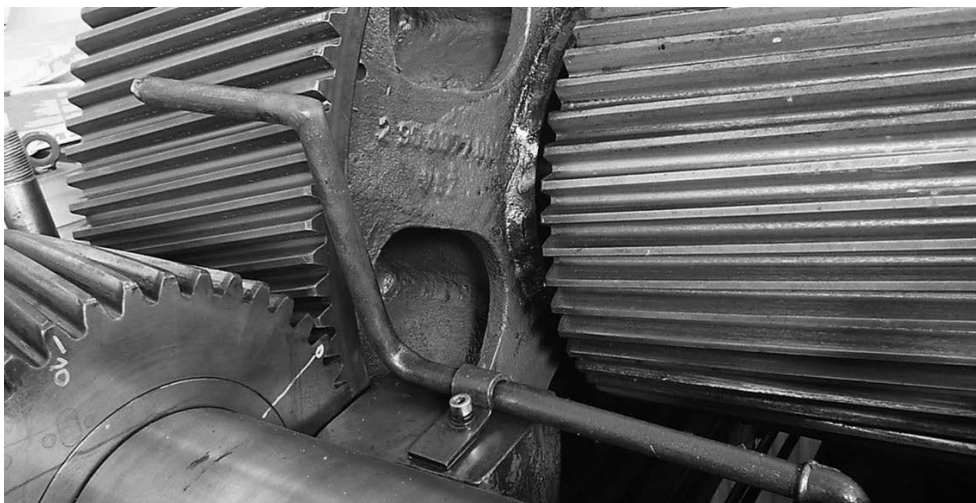
**Fig. 4** Forced lubrication of the first stage of the gear trains

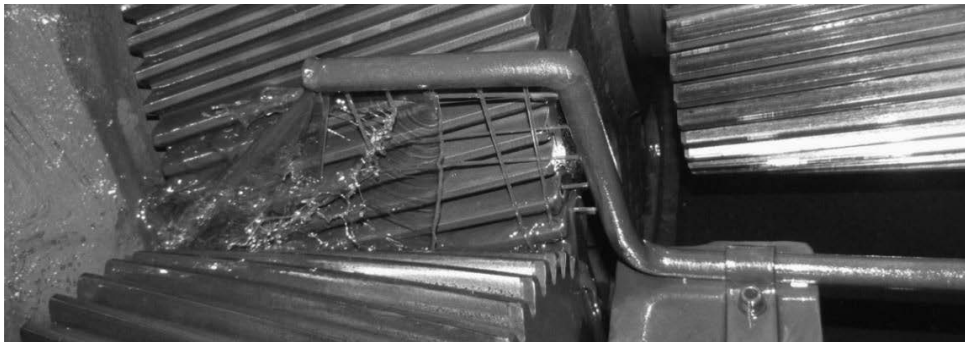
Installation of the gearbox into the ball mill drive in cement works is shown in the Fig. 5. The gearbox was operated in the opposite direction of rotation. The lubricant was pushed out of the first stage of the gear trains and sprayed on the viewing window as shown in the Fig. 6 and Fig. 7

**Fig. 6** Splash lubrication with the opposite direction of rotation

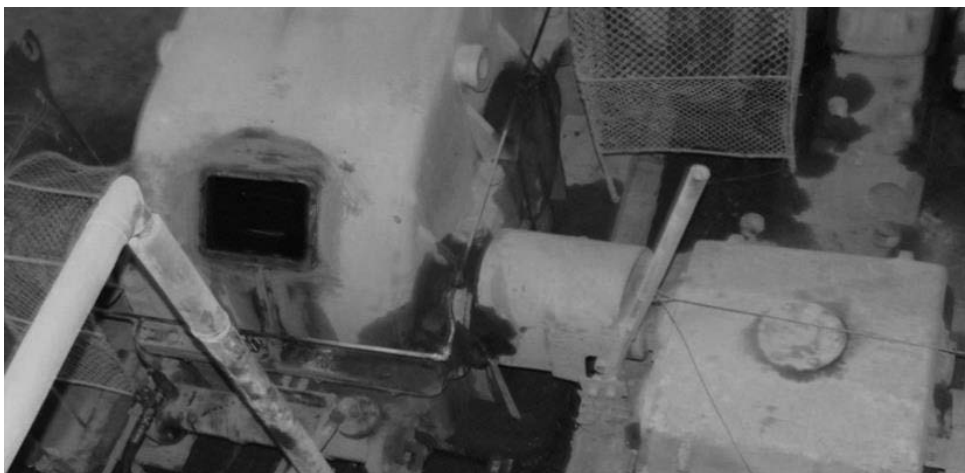
**Fig. 7** Viewing window sprayed with the grease

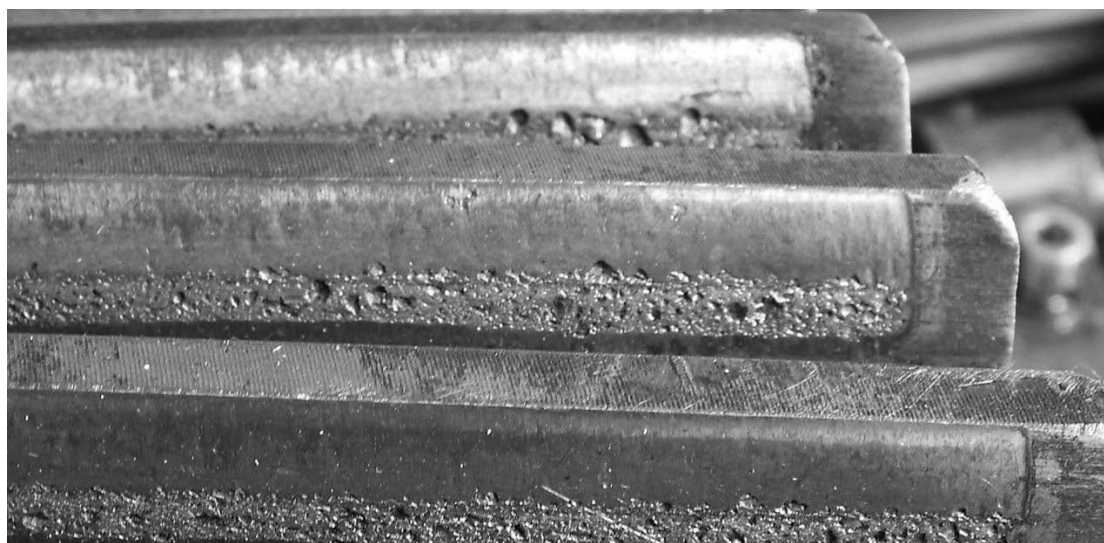
Due to the wrong lubrication of the gear, a pitting gear was formed, which caused considerable vibration. During operation, the gear unit in question was monitored and diagnosed each month. Diagnostic measured data of the vibrations and bearing condition are presented in Tab. 1,2,3.

**Fig. 8** Pitting gear

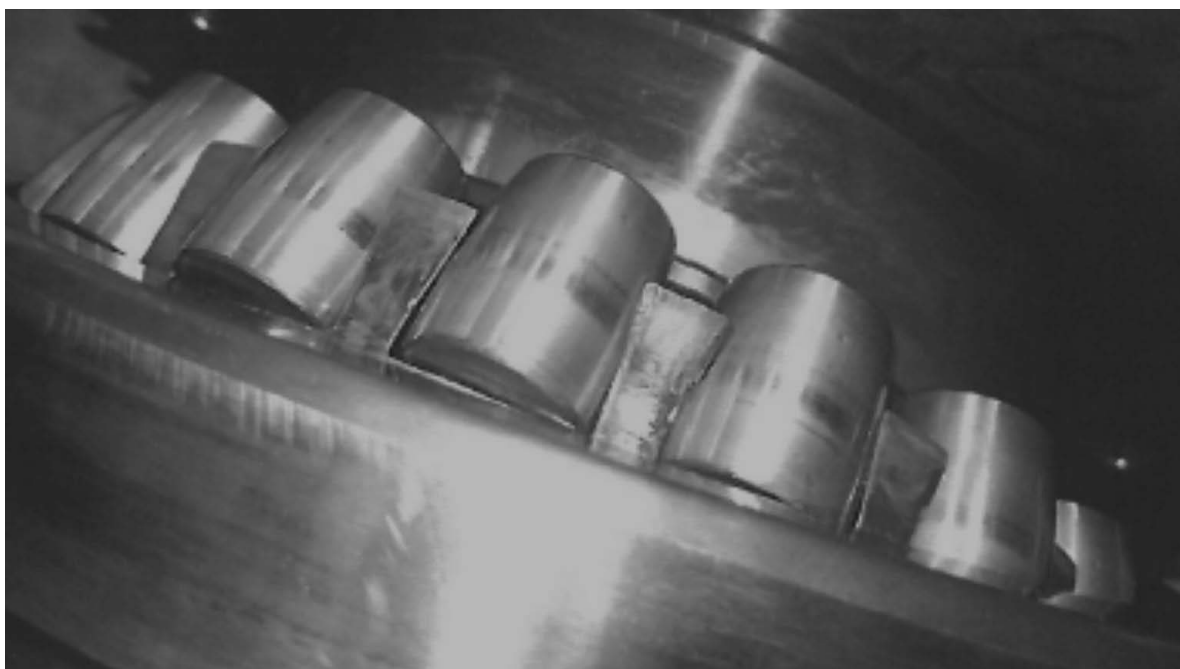
Damaged input shaft bearing on the engine side is shown in Fig. 9

**Fig. 6** Damaged input shaft bearing on the engine side

The wrong way of lubricating the gears damage not only gearing itself but also bearings, shafts, seals. Practically it destroy the entire transmission.
