## THE EFFECTS OF THE WRONG LUBRICATION METHOD OF THE GEAR TRAIN

*In the article it is presented the remanufactured gearbox of the ball mill drive in the cement works. The first stage of the gearbox gear trains is wrong lubricated in operation. And the consequences of this error in lubricating are shown and analyzed in the article.*

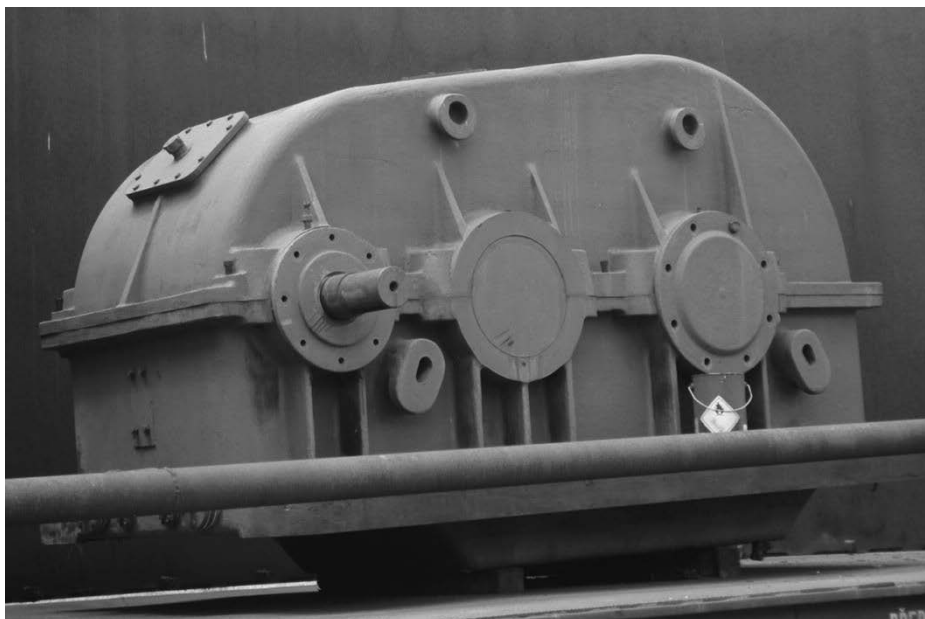
**Fig. 1** Gearbox TS before repassing

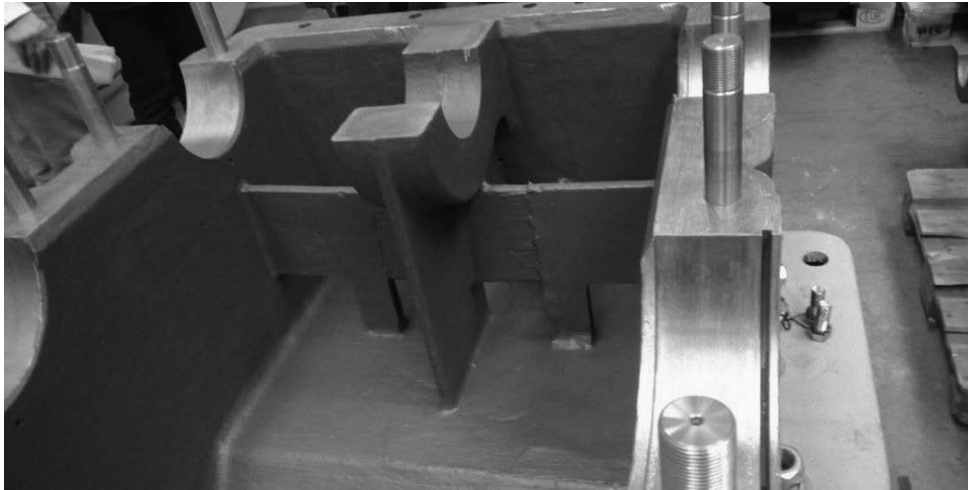
**Fig. 2** Gearbox after repassing

The gearbox repairs concerned the complete disassembly, pressing out shafts, removing rust from all parts, the repair of the shafts and the lids, the complete replacement of the bearings, the seals and the fasteners, machining dividing plane, machining bearing seats in the gearbox, design a new way of the lubrication of the first stage of the gear trains - circulation-system (the second stage of the gear trains is oil-bath lubricated), the restoration of the interior and exterior coats of the case body, coating and conservation, the complete assembly and testing (pressure test and run), as shown in the Fig. 2,3,4.

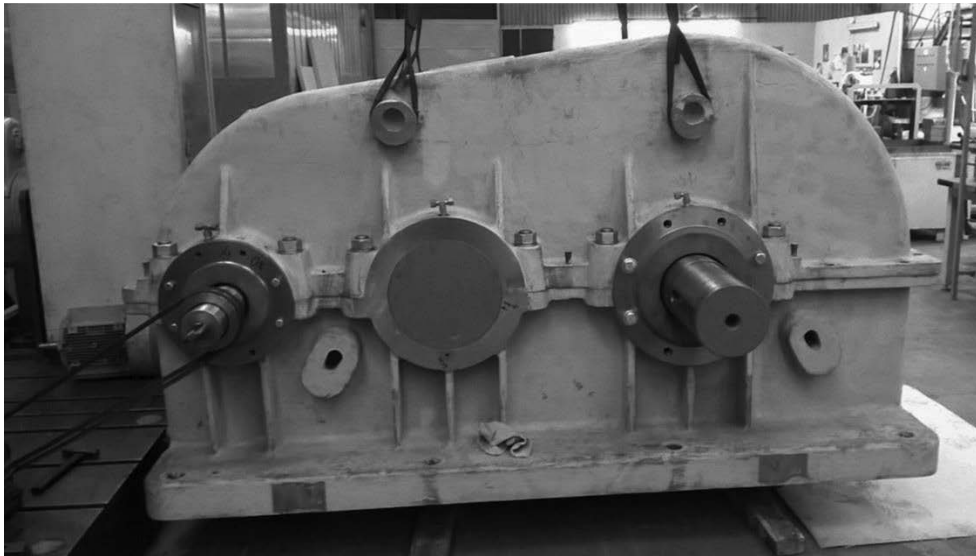
**Fig. 3** Gearbox testing

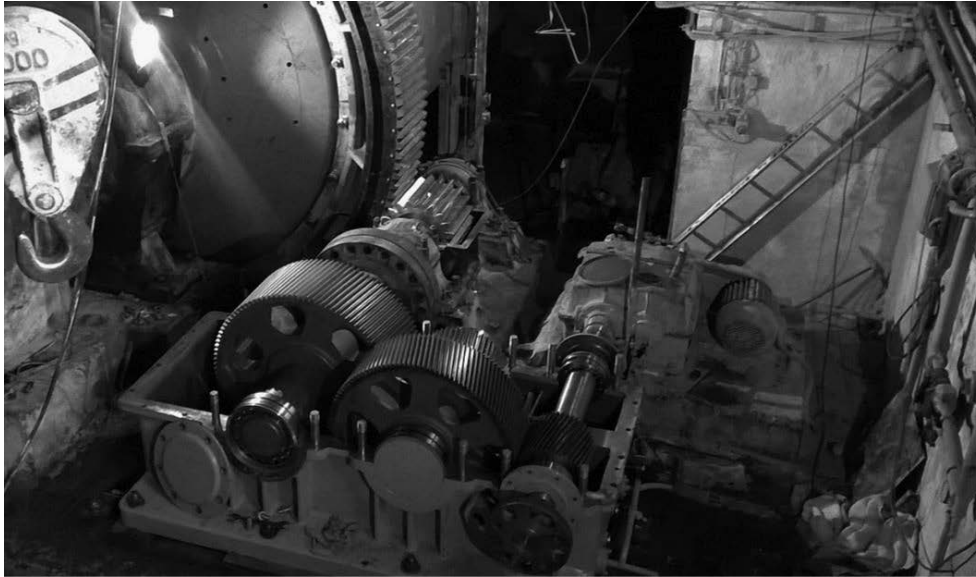
Installation of the gearbox into the ball mill drive in cement works is shown in the Fig. 5. The gearbox was operated in the opposite direction of rotation. The lubricant was pushed out of the first stage of the gear trains and sprayed on the viewing window as shown in the Fig. 6 and Fig. 7

**Fig. 5** Installation of the gearbox
